Mooloolah River Baseline Mangrove & Saltmarsh Condition Assessment

December 2017

Data Report

A Report for Bunya Bunya Country Aboriginal Corporation

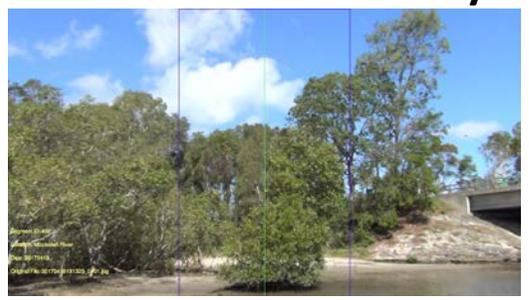
Mooloolah River Estuary Shoreline Mangrove Cover

Indicator:
The proportion of shoreline where mangroves are present

Mangrove Cover Score – Moderate

Recommended Actions:
Improve mangrove cover in the lower Mooloolah estuary, lower Mountain Creek and Parrearra Canal by incentivising landholder investment in living shoreline strategies such as 'mangrove gardens'.

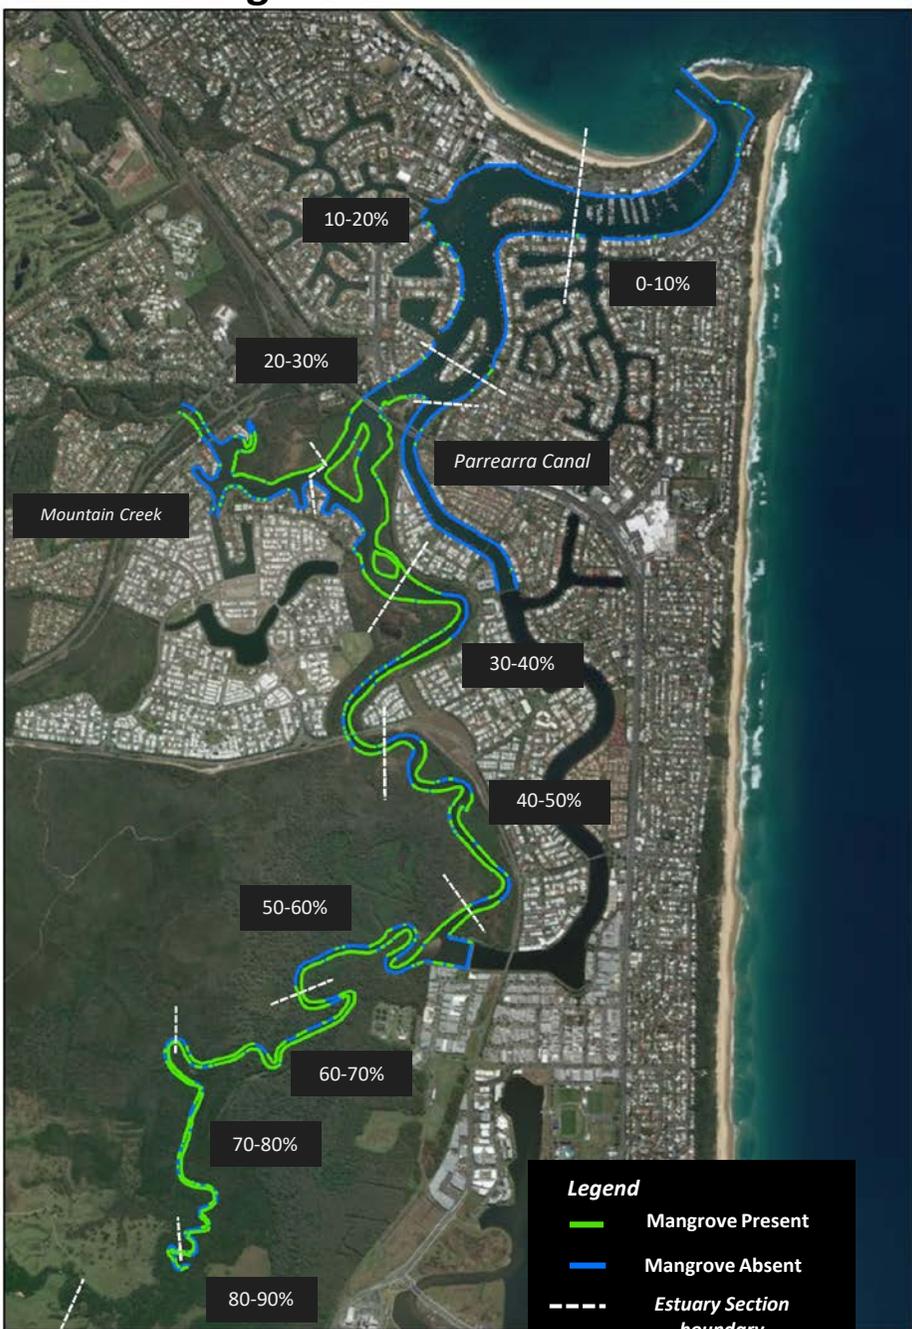
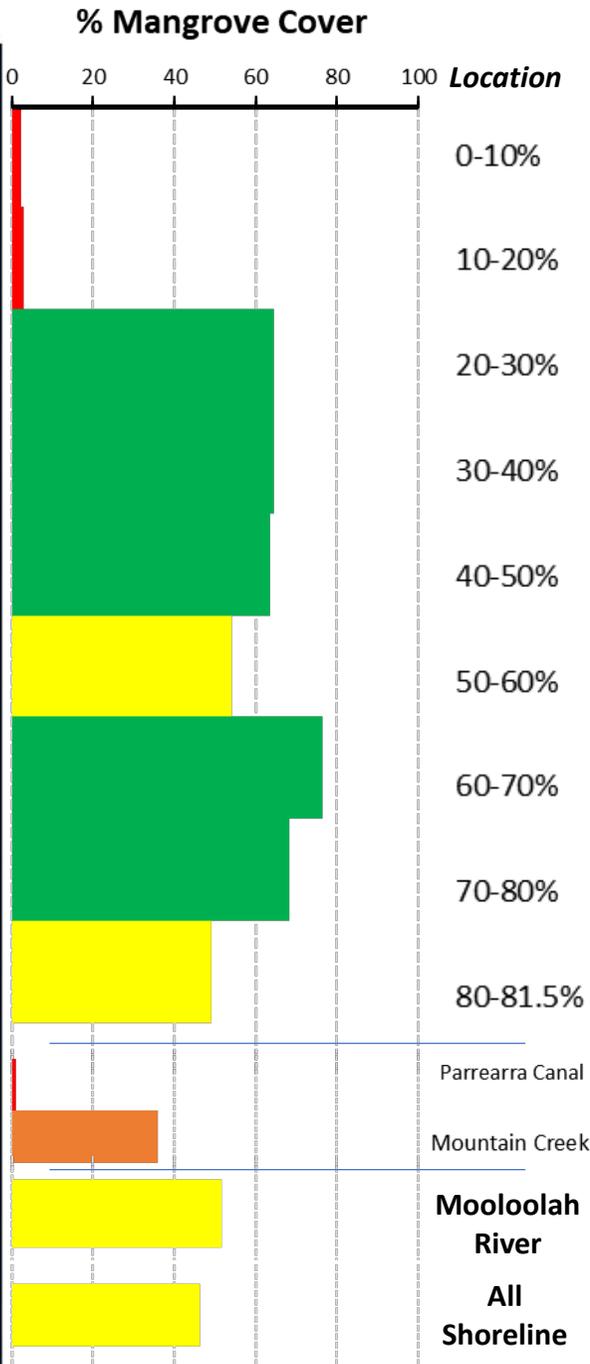
Implications:
Low mangrove cover means less fish habitat, less stable shorelines and less natural capacity to improve and maintain water quality.

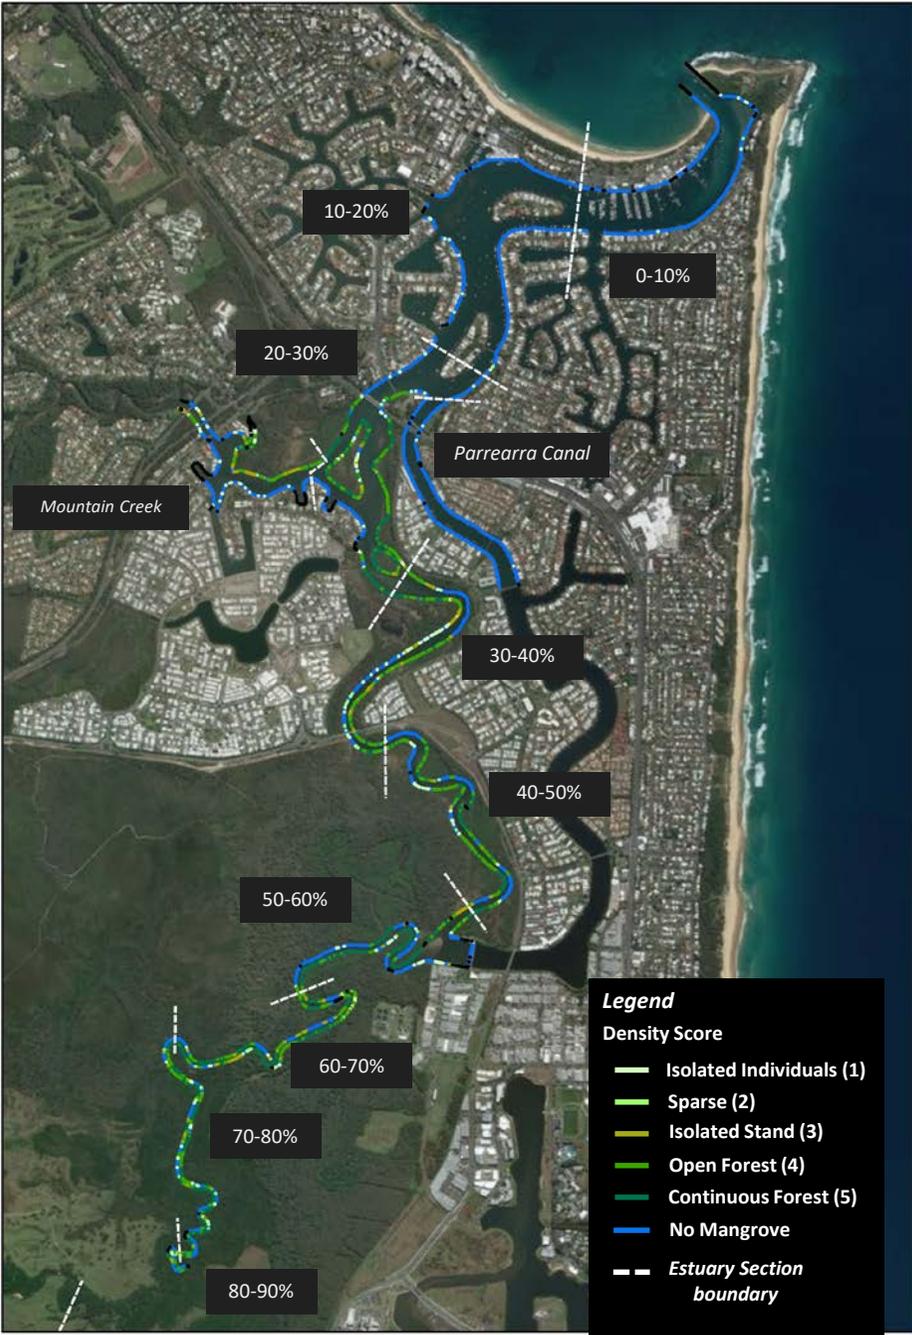
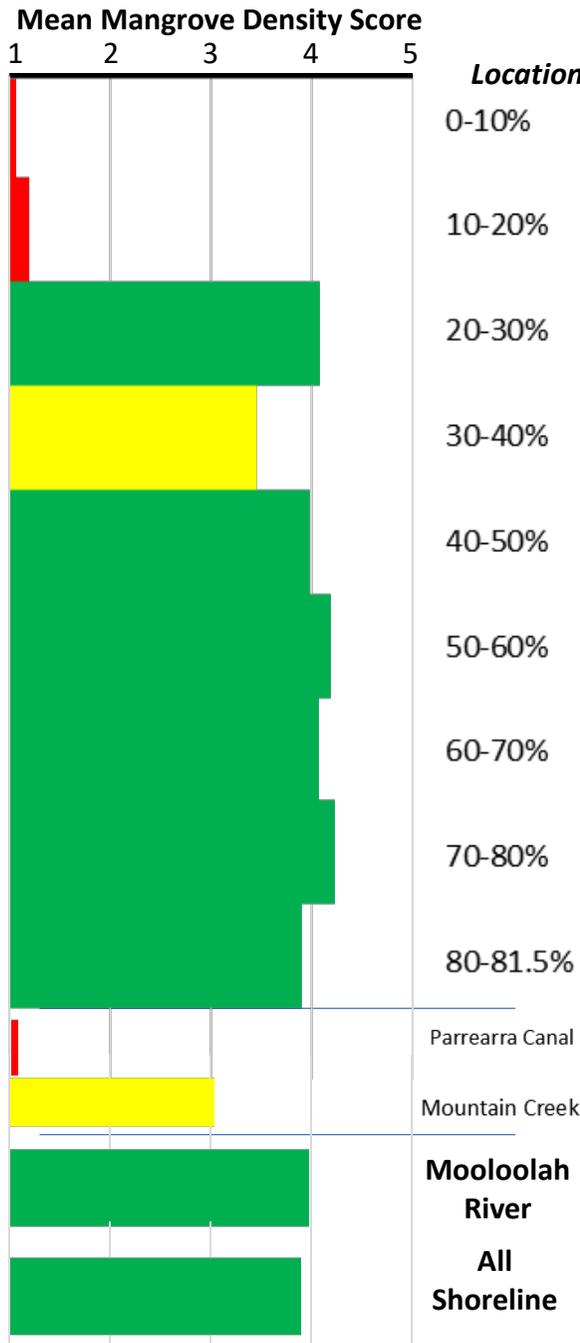
Indicator:
Mean density score (1-5).

Mangrove Density Score – Good (3.98)
Minimum: 1 - Lower 0-10%
Maximum: 4.23 - Upper-Mid estuary 70-80%

Implications:
Low mangrove density in the lower estuary means less stable shorelines, less natural capacity to improve and maintain water quality, and lower natural carbon storage. The combination of open and dense continuous mangrove stands in the mid and upper estuary provide good fish habitat diversity

Recommended Actions:
Create 'Living Shorelines' in the lower estuary, Mountain Creek and Parrearra Canal. Habitat creation can be designed to ensure mangrove growth is moderated to maintain river views for shoreline property.

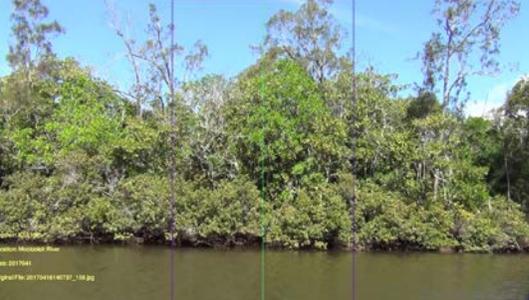
Mooloolah River Estuary Shoreline Mangrove Stand Maturity

Indicator:
Mean stand age (1-5)

Mangrove Maturity Score – High

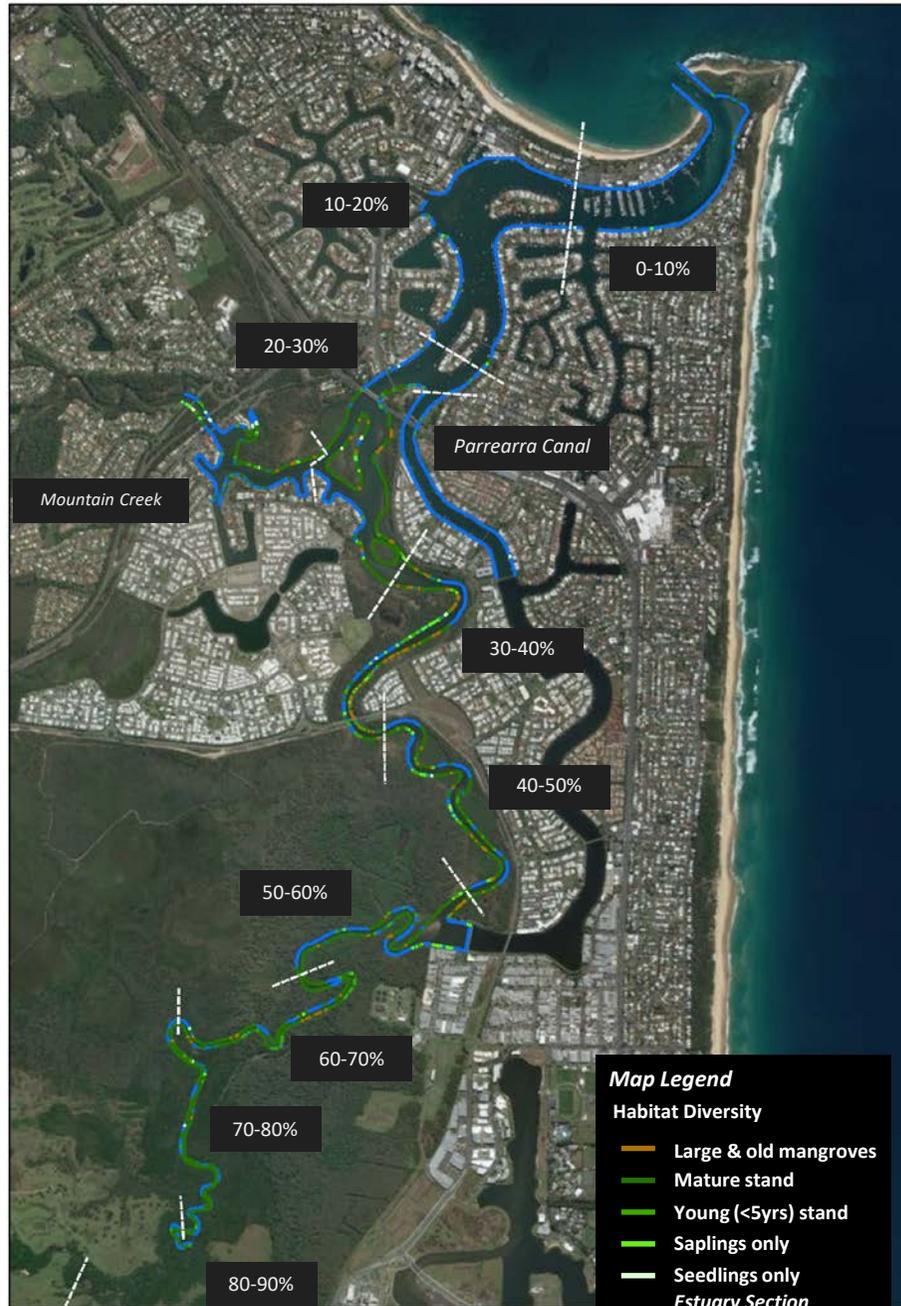
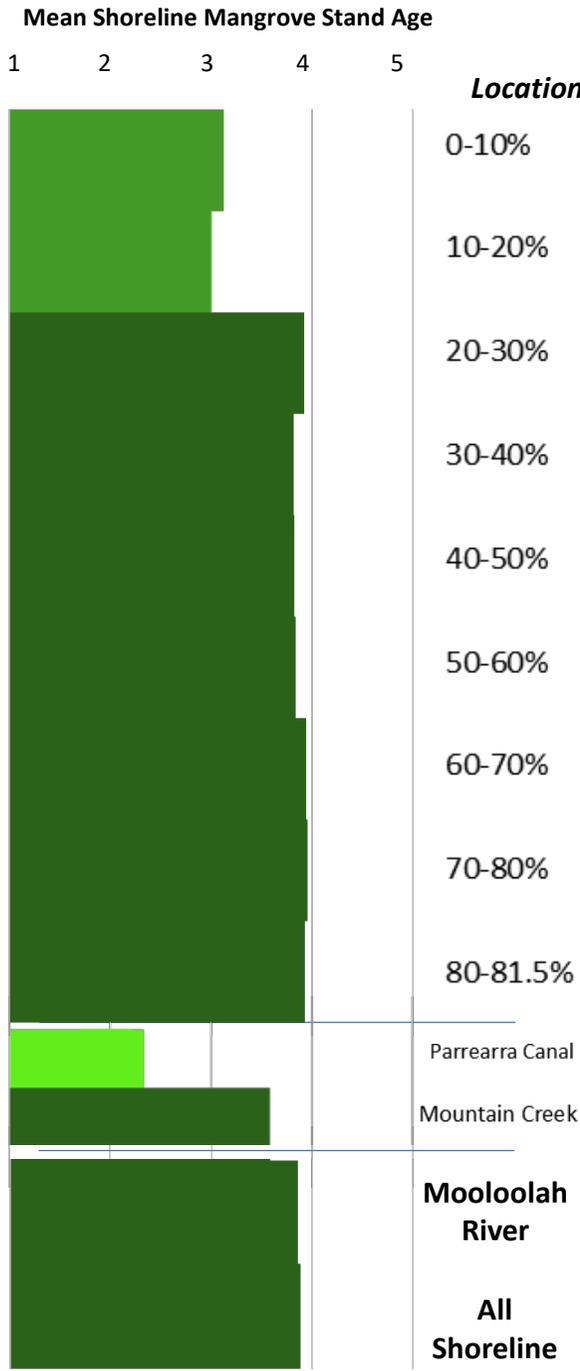
Implications:
 Large mangrove trees and mature mangrove stands provide increased ecosystem service value.

Recommended Actions:
 The mid-estuary (30-40%) has both the highest frequency of young mangrove stands and large old mangrove trees. This estuary section is therefore both valuable and vulnerable. Efforts to reduce human impacts, including boat wake should be undertaken.

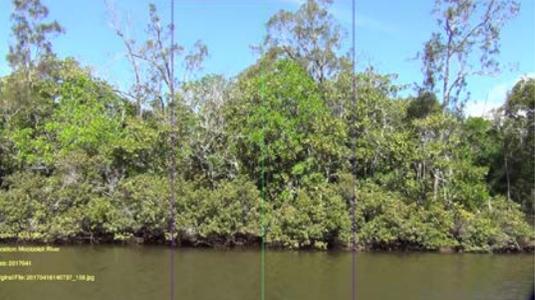
Mooloolah River Estuary Shoreline Mangrove Biodiversity & Habitat Diversity

Indicator:
Shannons Habitat Diversity Index (H')

Mangrove Diversity Score – High

Implications:
High mangrove habitat diversity increases habitat availability for different fish, aquatic organisms and wildlife.

Recommended Actions:
Create 'Living Shorelines' in the lower estuary, Mountain Creek & Parrearra Canal to enhance habitat diversity.
Protect groundwater resources and maintain hydrological connectivity surrounding the estuary and within the catchment.

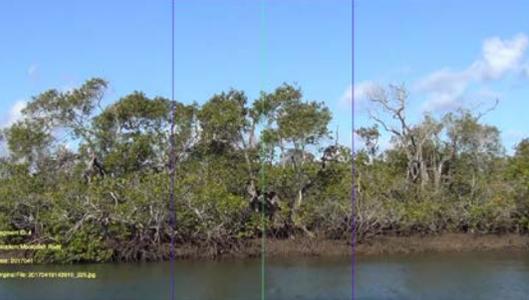
Mooloolah River Estuary Shoreline Mangrove Condition

- Excluding the lower 20% of the estuary, mangrove condition improves with increasing distance from the estuary mouth.
- Mangroves are in poorest condition in the lower-mid estuary (20-30%) ~3.5 km from the estuary mouth, where 18% of mangroves are in poor condition.

- Visual inspection of the Condition Map suggests that mangroves in poor condition are mostly located along the Eastern shoreline adjacent to urban landuse.
- There is minimal recent direct damage to mangroves for views and access impacting mangrove condition.
-

Indicator:
Density Weighted Condition Score (0-4)

Mangrove Condition Score – Good

Erosion prevention and control strategies should be implemented in the lower mid-estuary (20-40%) where poor shoreline mangrove condition is primarily linked to shoreline erosion.

- a) Construction of erosion control structures such as break-walls, using a living shoreline green-grey infrastructure design where mangroves are currently in poor condition (Refer to mangrove condition map).
- b) Implement and *enforce* waterway speed limits adjacent to vulnerable shoreline habitat

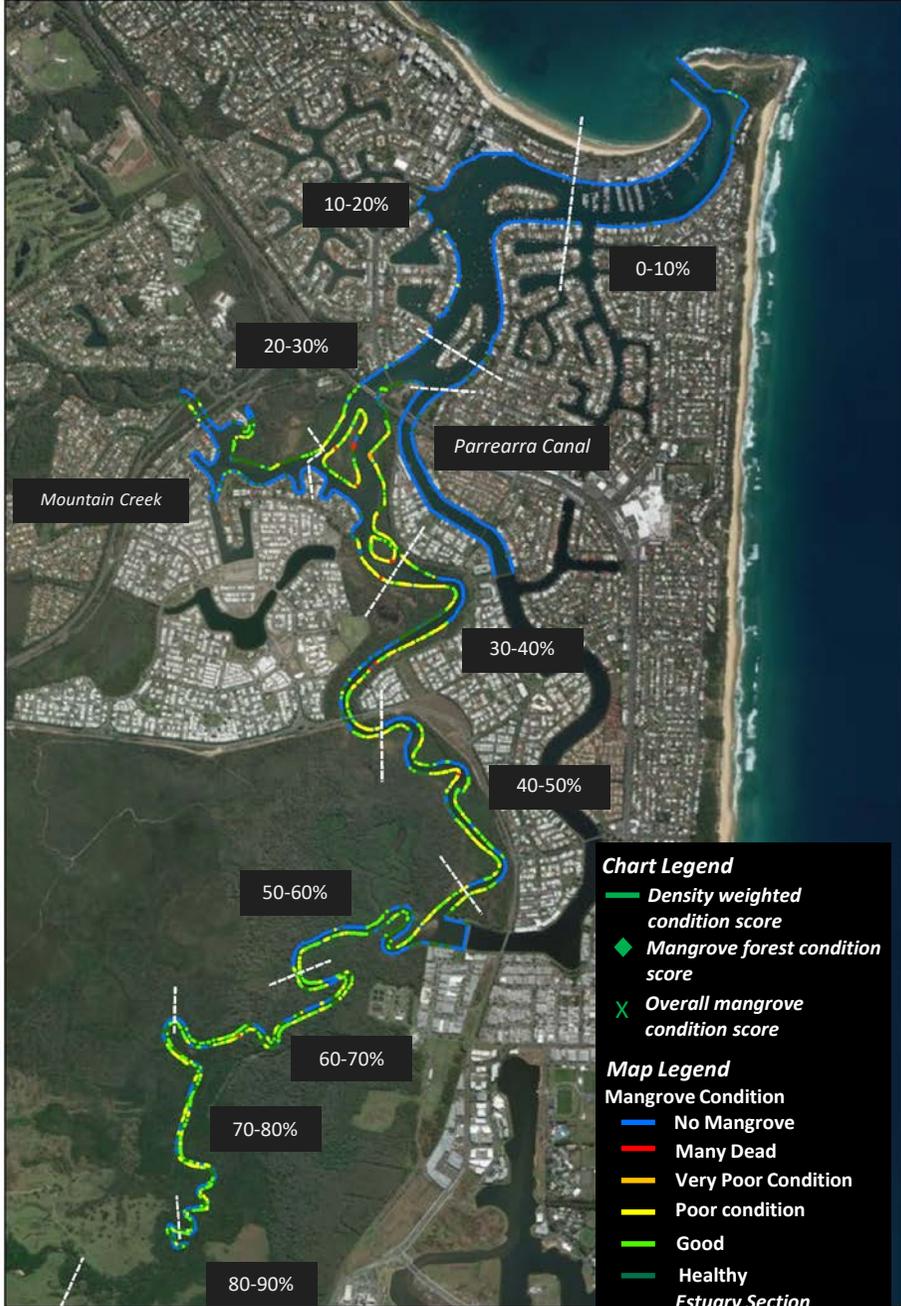
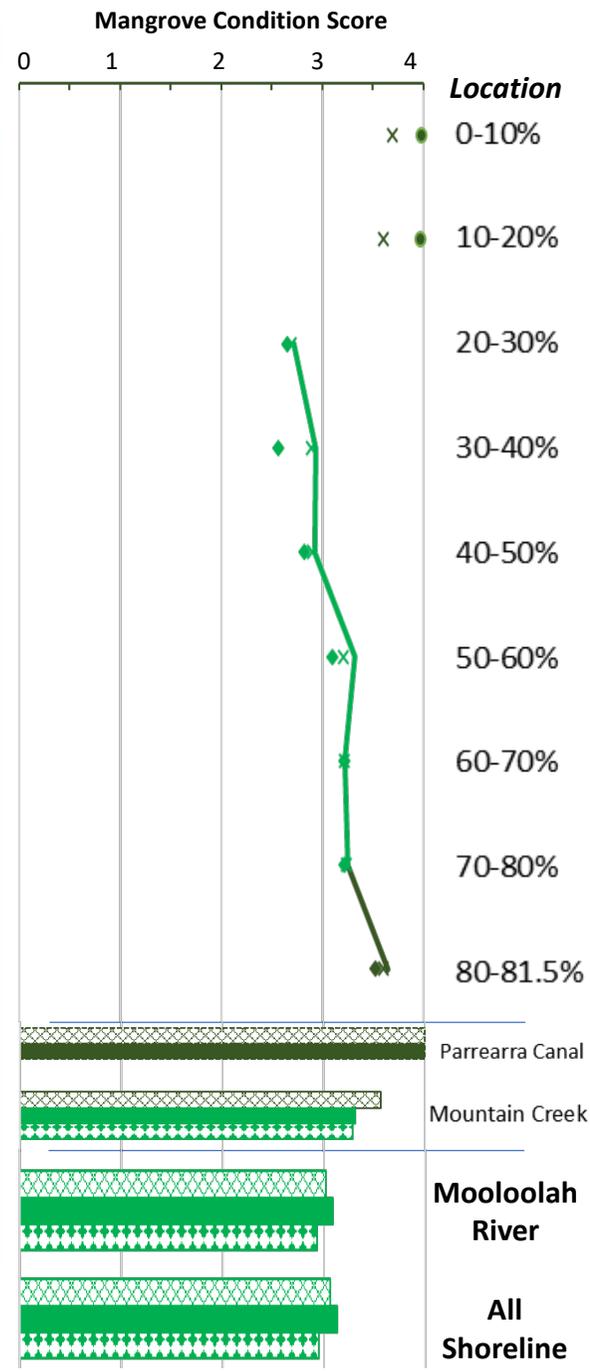
Overall: 3.09
 Minimum: 2.72 – Lower-mid estuary 20-30%
 Maximum: 3.65* - Upper estuary 80-81.5%
 Mean Forest Condition Score – 2.93

Mangrove condition increases with increasing distance upstream. Shoreline erosion appears to be the main driver of poor mangrove condition. Erosion in the mid estuary may be exacerbated by increased boat traffic and the effects of sea level rise. The mid-estuary is also subject to greater hydrological disturbance and increased pollutant runoff from surrounding urban land use. In the lower-mid estuary (20-30%), 21% of mangroves have dead trees present and 38% exhibit severe dieback. Mangroves in the Mooloolah River are in poorer condition compared to other SEQ mangrove systems.

Implications:
Human disturbance may reduce mangrove resilience to dynamic estuarine processes.

Recommended Actions:
Investigate the impacts of boat wake on mangrove habitat. Improve water quality in the lower-mid estuary. Consider shoreline stabilisation works to protect eroding mangrove habitat.

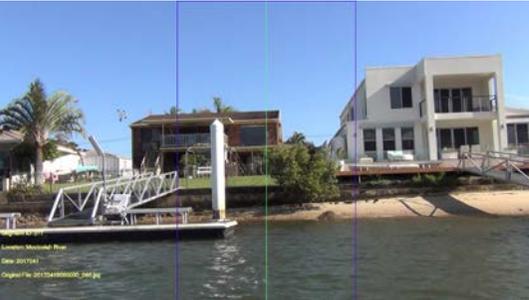
Mooloolah River Estuary Shoreline Modification

- 100% of the lower estuary (0-20%) shoreline is modified
- No shoreline modification was observed in the upper estuary (>70%)
- There are 356 artificial structures at 10.7 structures per km across the entire estuary, with the majority (291) being in the lower estuary. There are no structures upstream from ~12.5 km from the estuary mouth (>60%)

- The most commonly observed structures were pontoons and overhanging decks (215, 60% of structures)
- 24% of the shoreline is hardened with wall structures.

Indicator:
Proportion of shoreline modified

Shoreline Modification Score – Modified
 % Natural – 71.5%
 % Modified – 7.4%
 % Highly Modified – 21%

The historical loss of habitat and extensive shoreline modification in the lower estuary has led to a likely loss of estuary function. The Mooloolah River estuary has a very high number of artificial structures and high proportion of hardened shorelines. There is likely to be ongoing loss of shoreline habitat and deterioration of habitat quality in the estuary due to sea level rise and associated shoreline erosion.

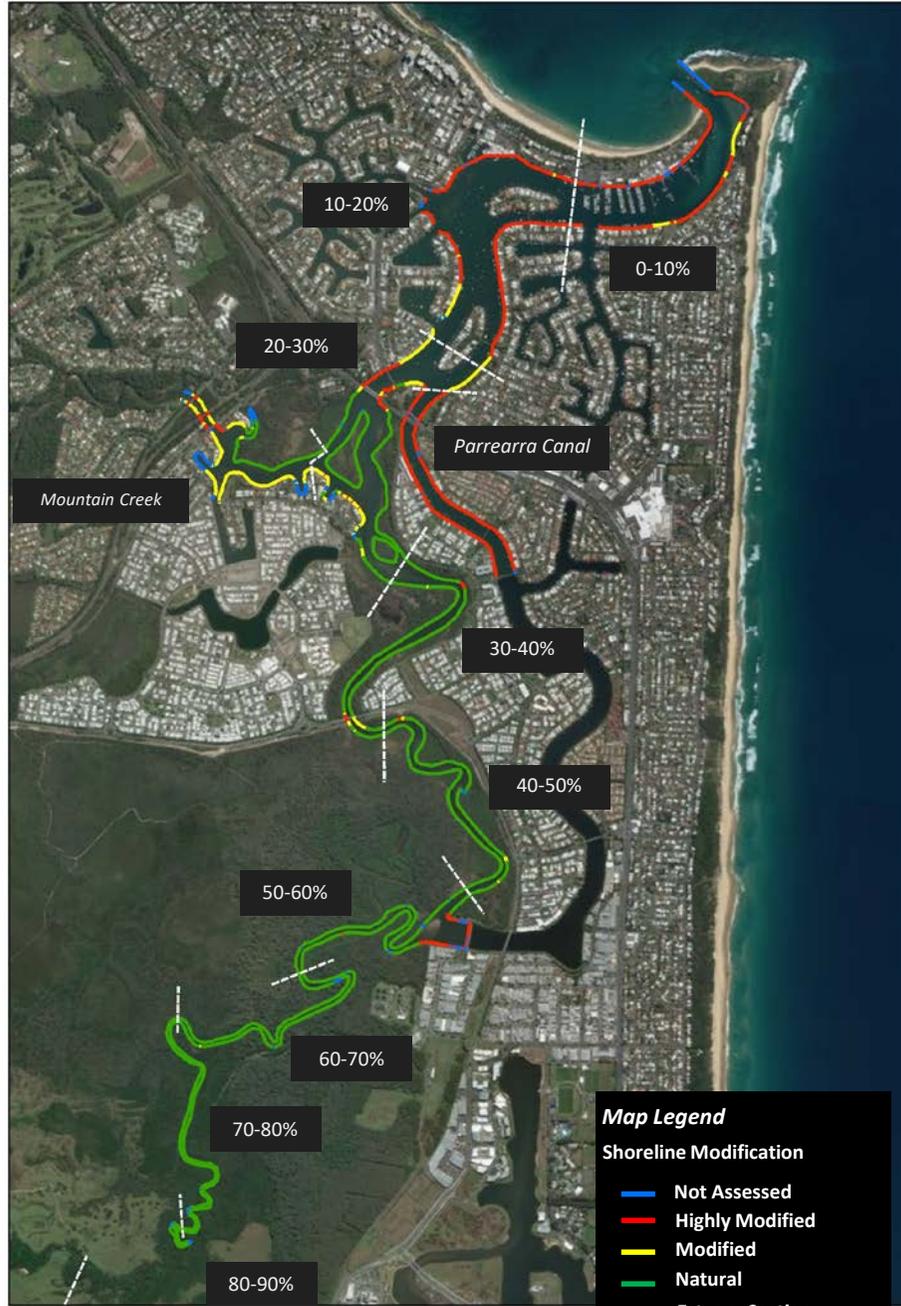
Implications:
 There is limited habitat diversity and natural substrate in the lower estuary. Although artificial structures and modified shorelines can provide fish habitat, their habitat potential is maximised if there is nearby natural habitats. Shading from pontoons and deck platforms reduce fish habitat function.

Recommended Actions:
 Encourage 'living shoreline' construction along lower estuary banks. New shoreline modification and artificial structures should be carefully considered, with requirements to incorporate natural infrastructure.

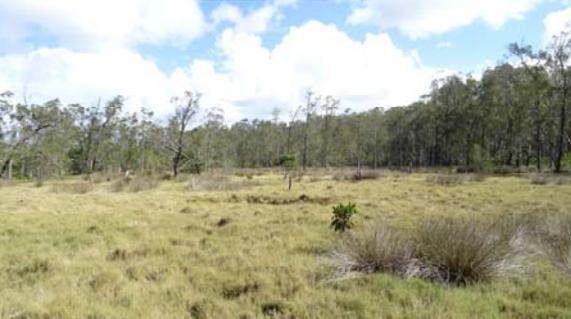
Moolooloolah River Estuary Saltmarsh Threats

Indicator: Mean threat score (0-4)

Saltmarsh Threat Score – Somewhat Impacted

Saltmarshes are sensitive environments. But these areas also have high recreational and amenity value in urban areas, accessed by fishers and walkers. Human trampling from pedestrian access was observed at 8 out of 10 sites. Areas of high pedestrian traffic were associated with damage to saltmarsh vegetation and surface erosion, leading to a loss of habitat quality. Pedestrian access control measures should be investigated at sites 1, 2 and 4. We recommend the following potential control measures;

- a) Improve community education for residents living adjacent to saltmarsh areas
- b) Install educational signs in vulnerable saltmarsh areas
- c) Improve controlled access for pedestrians at sites 2 and 7, in the form of a boardwalk or, restrict access to these sites.
- d) Restrict landward access to site 1. This is also required to prevent vehicle and bike access to this site.
- e) Improve policing of illegal camping in adjacent habitats, particularly sites 1, 6 and 7.

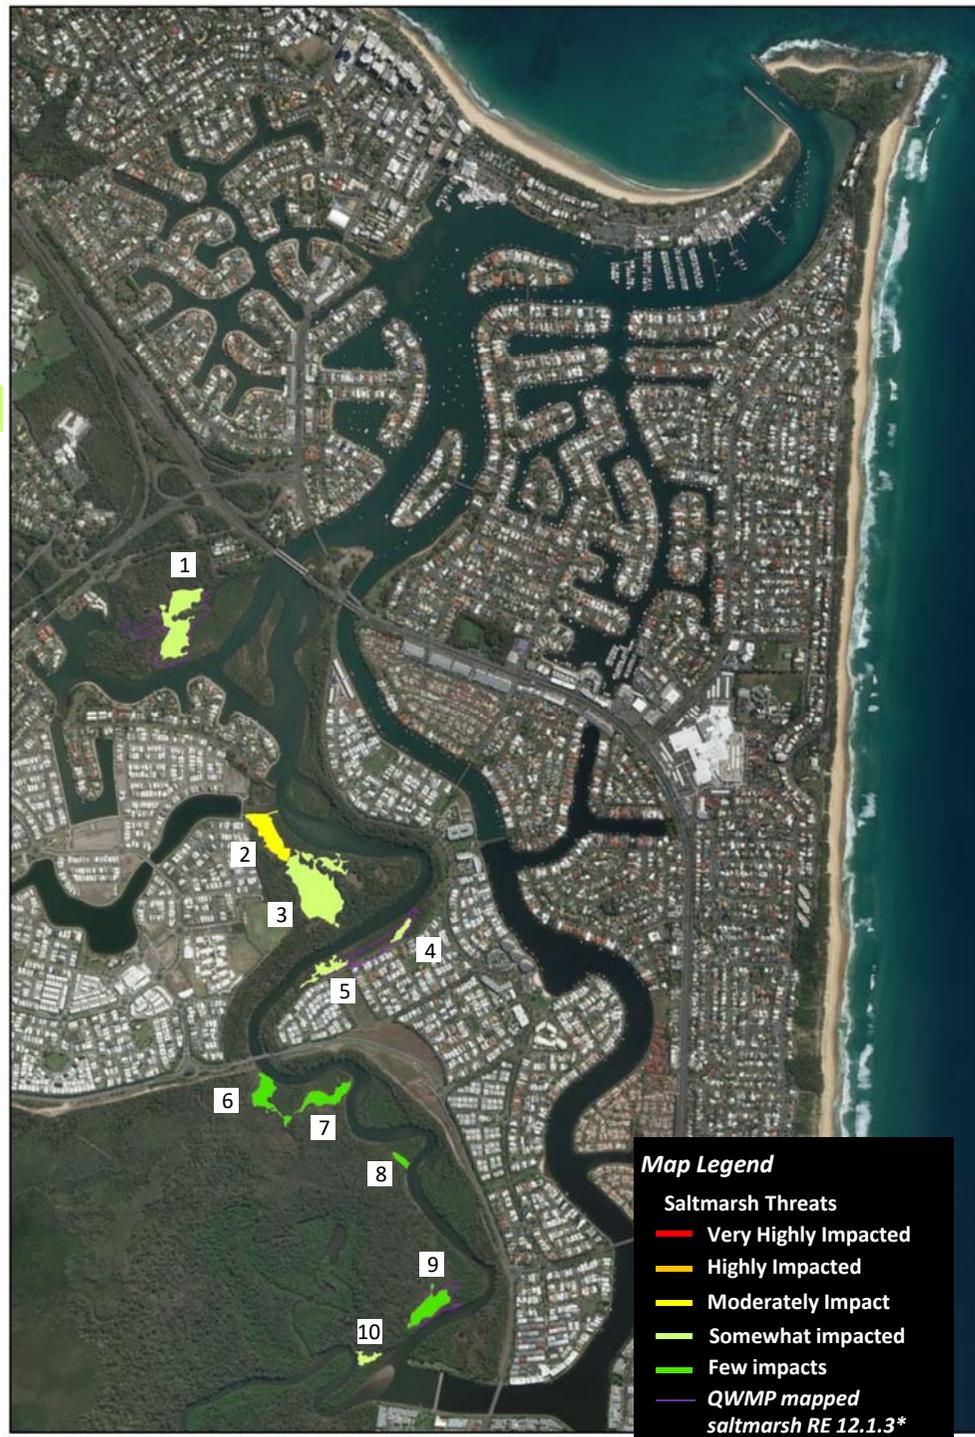
Moolooloolah River estuary saltmarsh areas are relatively healthy for such an urbanised setting. Dumped rubbish/litter indicates a lack of local community awareness regarding saltmarsh habitat value. All saltmarsh habitats are at extreme risk of sea level rise. Mangrove encroachment and *Casuarina* and *Melaleuca* dieoff indicate recent local sea level rise. Uncontrolled access of vehicle and pedestrian traffic damage saltmarsh plants, exacerbate surface erosion and reduce ecosystem resilience to sea level rise. Weeds like *Asparagus fern* and *Groundsel* within buffer zones limit the natural capacity of saltmarsh to retreat landward with sea level rise.

Loss of saltmarsh habitat means loss of important fish and bird habitat, and reduced estuary water quality. Damage to saltmarsh surfaces and loss of vegetation increases sediment runoff to the estuary.

Increase local awareness of saltmarsh value
 Restrict pedestrian access to saltmarsh areas.
 Install rubbish bins and fishing facilities at site 10. Prevent illegal camping in coastal habitat. Remove weeds from buffer zones. Ensure urban planning considers future saltmarsh upland retreat and prevent coastal squeeze.

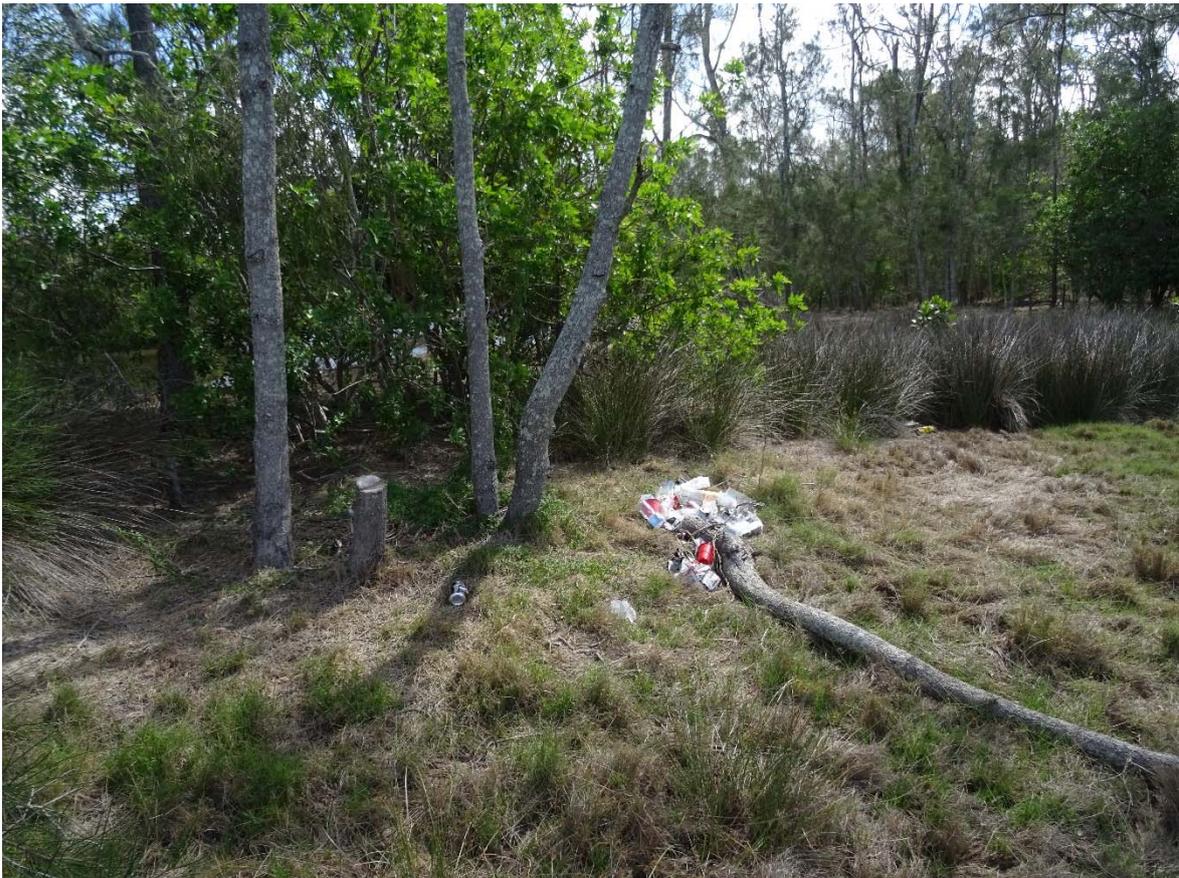
Figure 6 Trash and vegetation damage at a fishing camp at saltmarsh site 10 in Mooloolah River NP.

Shoreline erosion is threatening saltmarsh habitat at sites 8 and 10 within the Mooloolah River National Park. Uncontrolled fisher access at site 10 is contributing to shoreline erosion. Given the small area of remnant saltmarsh in the Mooloolah River estuary, all efforts should be undertaken to protect remnant saltmarsh. To reduce shoreline erosion at these sites we recommend the following;
